Ecological Management Plan

**Kingfisher Pond
Northstowe**

January 2024

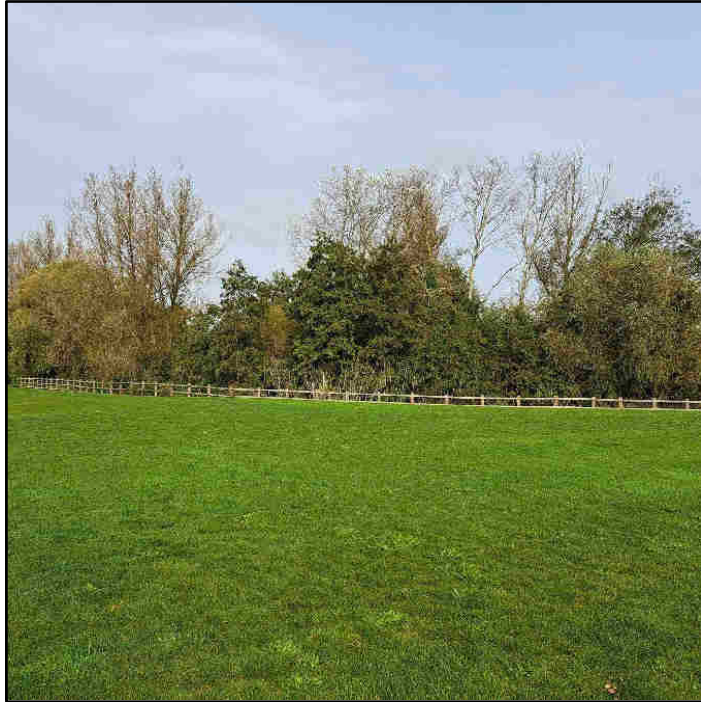
Photograph 1: Trees and Fence Surrounding Kingfisher Pond

Kingfisher Pond is a natural water feature surrounded by a thin belt of trees and shrubs within a fenced off area (Photographs 1, 2 and 3 below). A wooden viewing platform (Photograph 4) was accessible from a gravelled footpath on the eastern side of the pond to facilitate access by local residents of the Northstowe development. The encircling bankside vegetation is expected to restrict access to the pond elsewhere but the continual fencing around the pond is presumed necessary to deter access to the pond itself completely.

5. To improve sunlight penetration into the aquatic habitat and pond margins, open up parts of the tree belt around the southern bank by selective thinning of overhanging trees and any shrubs and trees causing excessive shade. This can be achieved by coppicing suitable trees.

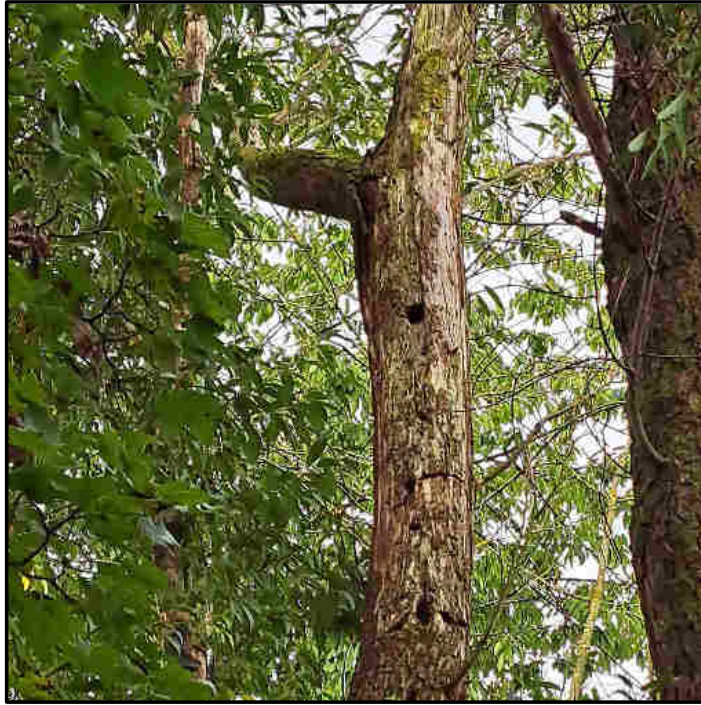
Photograph 5: Deadwood Habitat

Terrestrial vegetation within the fenceline comprised trees of varying age classes, including some dead wood in the canopy (Photograph 5), young self seeded trees and shrubs with ground vegetation of grasses (e.g. Cock's foot grass *Dactylis glomerata* and creeping bent *Agrostis stolonifera*), nettles (*Urtica dioica*) and a stand of hemlock (*Conium maculatum*) in the southern section (under treatment).

Retain all dead wood in the canopy as valuable habitat for a range of wildlife including bats which may roost in suitable hollows and crevices. Should any deadwood need to be removed for safety reasons, survey for bats should be undertaken prior to removal.

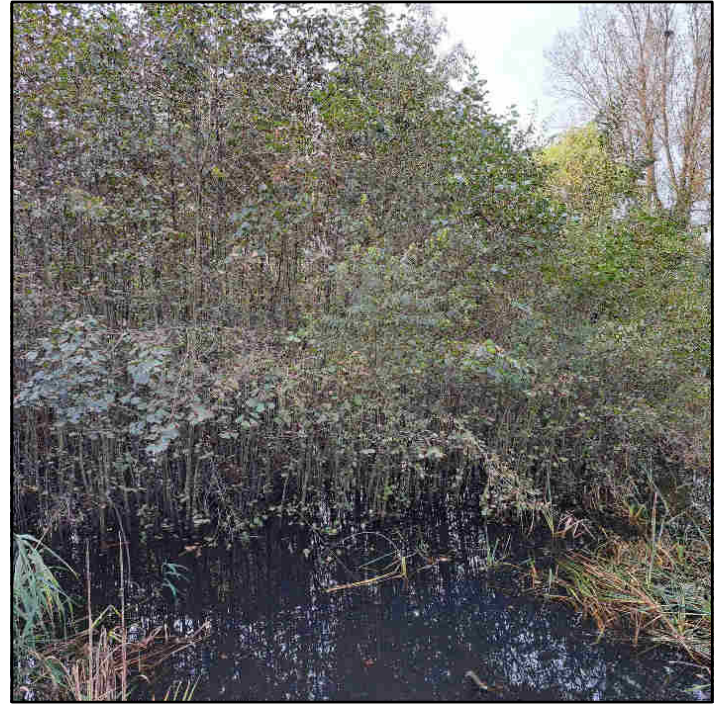
Photograph 6: Alder Encroachment

Natural successional changes were evident within the pond, with significant encroachment into the water body by alder (*Alnus glutinosa*) and reedmace (*Typha latifolia*). This encroachment covered the vast majority of the pond (Photographs 6, 7 and 8). There was a general lack of aquatic vegetation visible and marginal vegetation⁴ was extremely limited.

Wetland and water tolerant plant species, primarily alder and reedmace, have encroached into and across the pond area resulting in a significant loss of water surface area.

4. Remove all alder and reedmace from the former open water sections of Kingfisher Pond i.e. from all former water holding areas. This should include removal of the alder roots and the reedmace rhizomes right up to the edges of the pond.

In order to avoid significant disturbance to the pond habitat and its wildlife as well as to avoid excessive disturbance of sediment, this work should be undertaken over a 3 year period during the winter period¹⁰. Approximately one third of the area of alder, and one third of the area of reedmace should be removed each year.

The removal should start from the central part of the pond and work towards the banks in order to increase the area of open water early in the management programme and secure biodiversity benefits as soon as possible.

Ultimately it will be desirable to retain some small, limited areas of reedmace within the pond habitat through annual maintenance work. Similarly some natural growth of alder in the edges of the pond can add biodiversity benefit due to the physical diversity of the aquatic habitat created by its root structure, but this should be kept to a minimum and not be allowed to develop so that it shades open water.

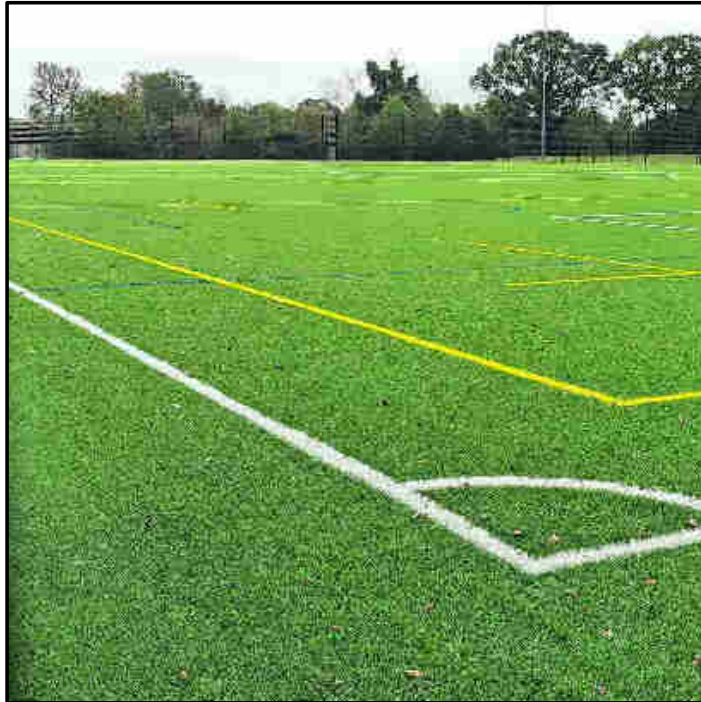
Photograph 9: Artificial Sports Field to West of Kingfisher Pond

Sports fields were present to the south and west of the pond, with the closest being an artificial pitch (Photograph 9). This artificial pitch drained into Kingfisher Pond via artificial drainage pipe (Photograph 10), and a pond overflow pipe was located in the south western corner (Photograph 11). At the time of the site visit the outflow was notably higher (about 500mm) than the water surface of the pond, which indicates a relatively low water level within the pond at the time.

In addition, as the pond now receives drainage from the adjacent artificial sports pitches, it is expected to receive pollution in the form of microplastics and leachates washed from the pitch surface. Depending on the type of pitch, this pollution is likely to comprise a mix of Styrene Butadiene rubber (SBR) from recycled car tyres and various plastics. Leachate from these materials has been shown to contain toxic chemicals such as bisphenol A, Poly Aromatic Hydrocarbons (PAHs) and metals such as zinc⁷. There is also emerging evidence that 6PPD (a car tyre preservative) is highly toxic to some aquatic species⁸.

Regardless of the type of artificial pitch constructed, a suitable filtration system is highly likely to be required.
