## **Northstowe Town Council - Hydrology Working Party**

**Meeting Purpose:** To instigate actions 1, 2 and 3 from the Town Council's hypothesis as presented in agenda item 21-22/197.

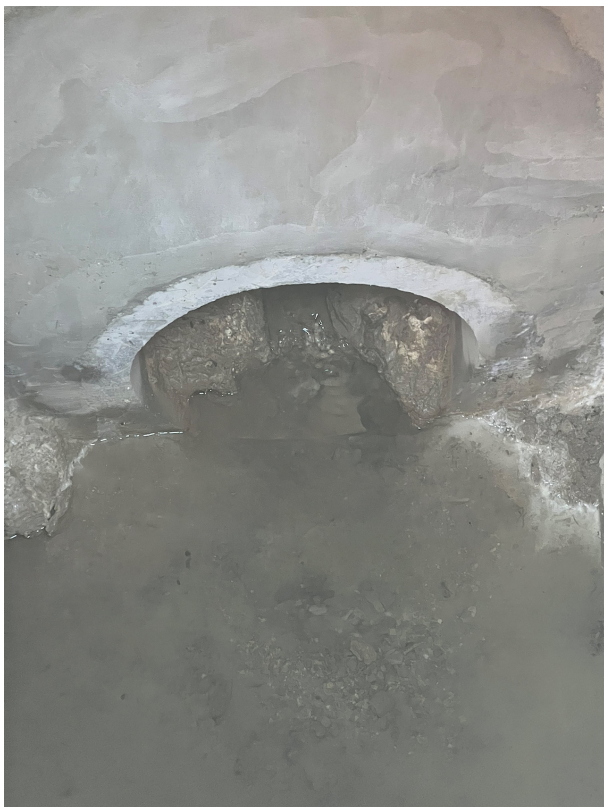
Initially chamber S419 was opened and there was clear evidence of running water coming from the spur from H9 marked as S422H. As this was evidential enough we decided there was little value in opening S420 as the water could be visibly seen to travel in the direction of S420. Video was taken by Cllr Littlemore, which has subsequently been filed with the Clerk, showing the flow clearly. It was discussed that site dewatering may explain this flow, however there were no visible signs of active pumping of water on the site from the boundary.

Figure 1: Water ingress from S418ST in Chamber S419

FA1: Greater Cambridge Planning to confirm with BDW whether the flow of water observed in S419 relates to any of their construction activity and arrange for a CCTV survey of the drain to confirm the source.
