# Kingfisher Pond - Northstowe Hydrogeological Assessment

## Phase III Report

FWM8714-RT003-R01-00

May 2021

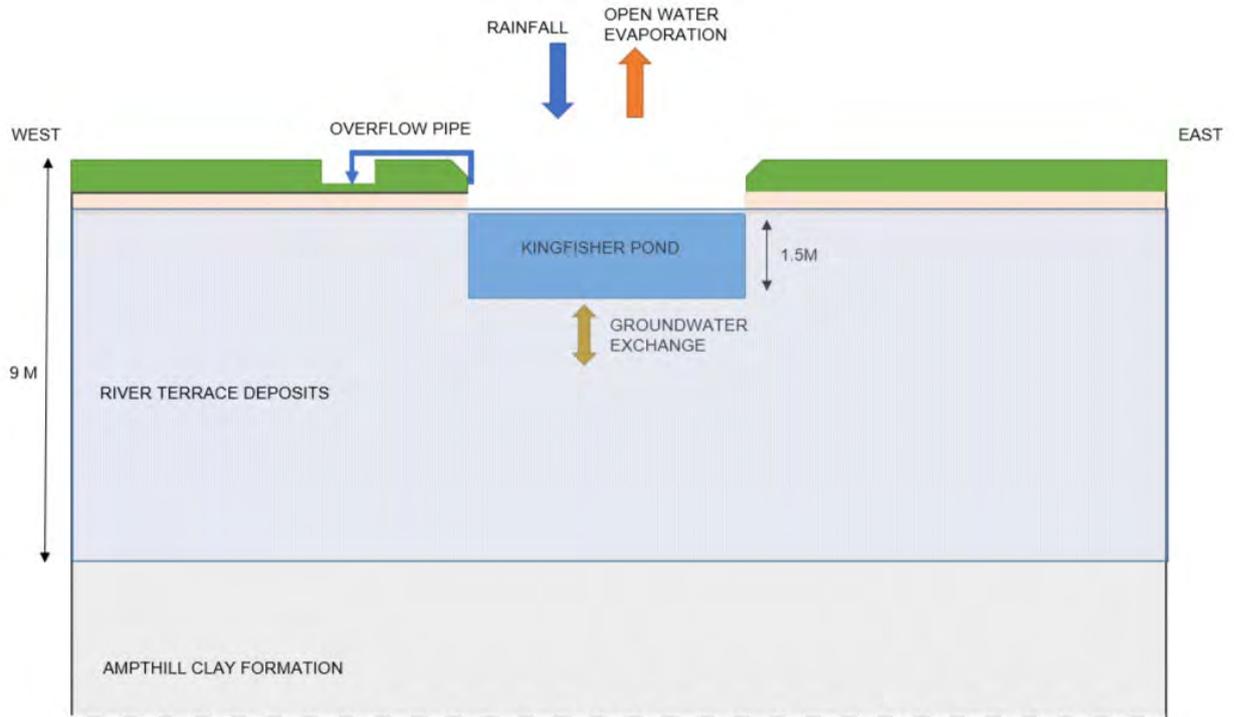
Figure 3.1: Schematic diagram describing the hydrogeological interaction of the Kingfisher Pond with the RTD aquifer

Figure 3.1 presents a conceptual diagram of the pond and the underlying geology. This diagram displays a conceptualisation of the exchange between groundwater and surface water. Figure 3.2 present the BGS 1:50 000 drift deposit map (BGS, 2020c) highlighting the location of the Kingfisher Pond within the RTD.

Source: HR Wallingford (2021a)

Notes: All measurements are approximate.

- The Kingfisher Pond has been a continual feature in Longstanton for many decades since it was dug out in the late 1960/early1970's;
- The pond is situated in the centre of the RTD and confined below by the Ampthill Clay (AmC) (BGS 2020a, BGS 2020b) (Figure 3.1; Figure 3.2);

- The depth of the pond (when full) is less than 2 m. Because it is a shallow pond, a small drop in groundwater levels can significantly affect the pond;

- The pond and RTD are in hydraulic continuity, so there is exchange of water between the pond and the RTD, which means that the water level in the pond will change as groundwater levels in the RTD change;

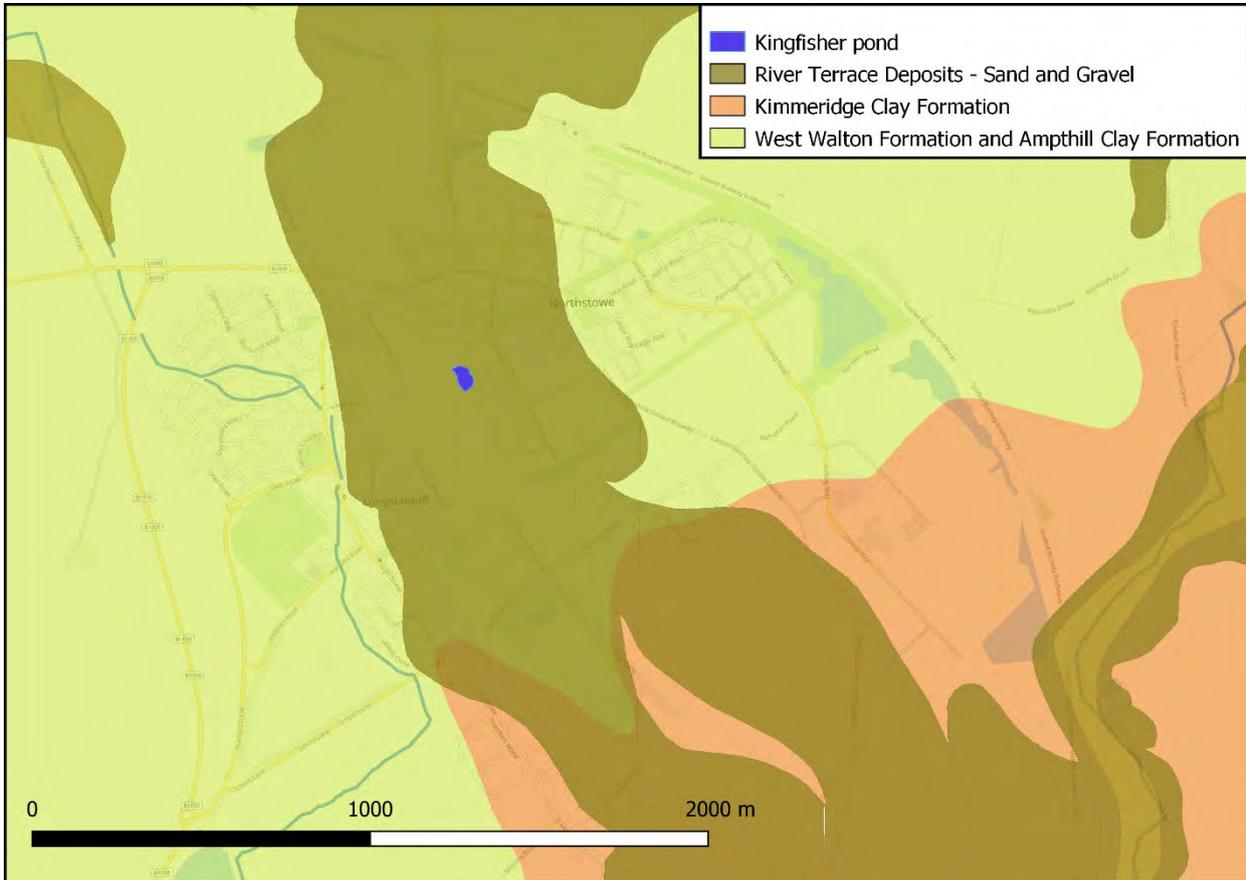
Figure 3.2: Geological map showing location of the Kingfisher Pond on the RTD

Source: *British Geological Survey 1:50 000 drift and bedrock geology, reproduced in QGIS. All rights reserved. OpenStreetMap reproduced in QGIS.*

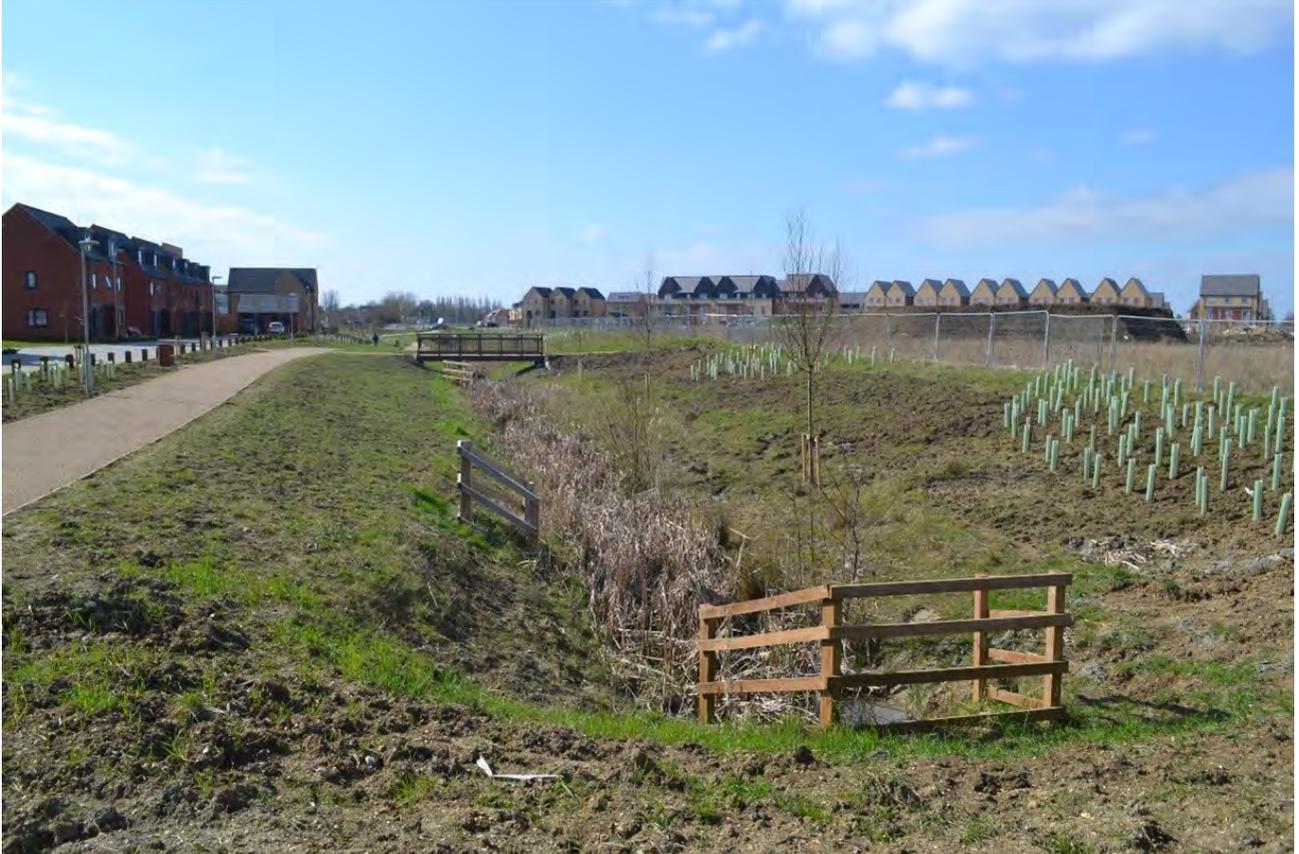
Photograph 4.1: Greenways on the site of Northstowe

The design of Northstowe includes the installation of ditches (referred to as greenways) to prevent flooding. These greenways provide a preferential flow pathway allowing water to travel attenuation ponds. A key design principle was to maintain the greenways above the water table otherwise the greenways would convey groundwater from the aquifer towards the attenuation ponds (Wardell Armstrong, 2017). Given the shallow groundwater table, careful construction of the greenways would be required to prevent permanent lowering of the water levels in the RTD.

WSP (2014) state that the typical water level in the RTD is 0.5 to 2 m below ground level. Photograph 4.1 (HR Wallingford, 2021) shows a typical section of one of the greenways. In this photo it is apparent that there are long sections of the greenways which are greater than 0.5 m deep. It is unclear if the design principle of maintain the greenways above the water table has been met. There is a possibility that these greenways are located below the natural water table in the RTD in some sections.
