## Northstowe Town Council - Hydrology Working Party

### Background

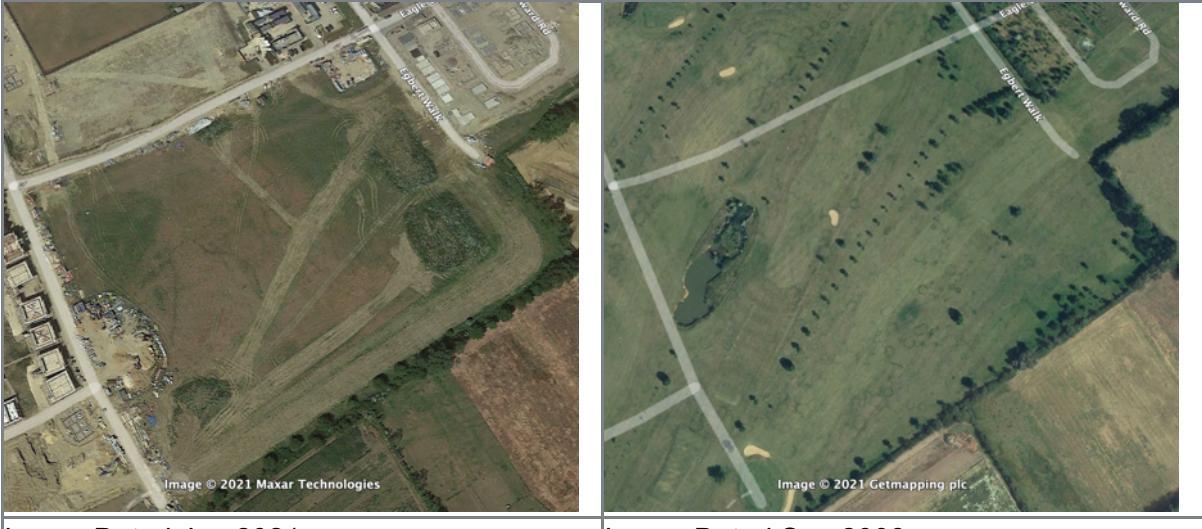
Figure 1: Aeral photography of the site of H9 (Source: Google Earth).

Image Dated Jan 2021.

Image Dated Sep 2008.

Representations made to the Town Council from BDW described the need for pile driving in the eastern edge of H9 as being attributed to the fact the site previously had a pond within and hedging damaging the ground structure. Inspections of historical aerieal footage shows that the pond that needed to be filled in was on the western edge as showin in Figure 1. There is also no significant hedgeline along the eastern edge that is in question that would seemingly explain the unstable ground conditions.

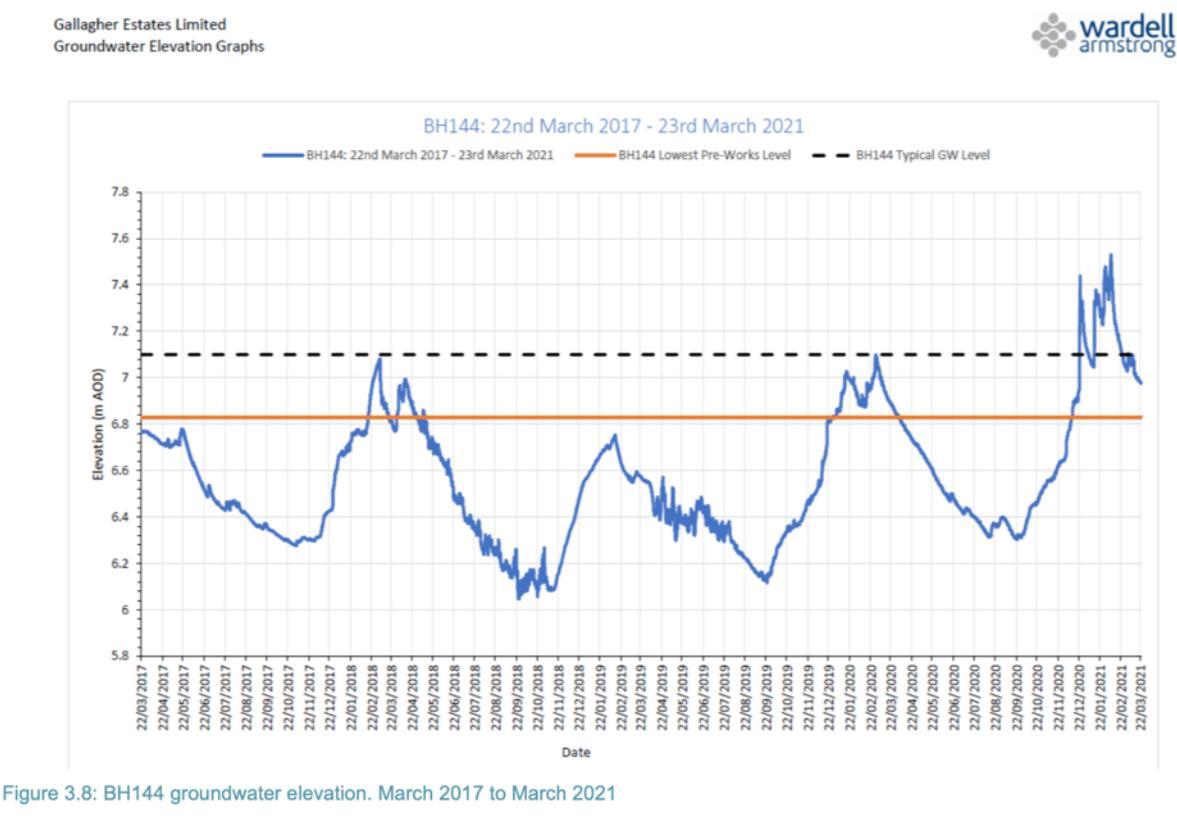
Figure 2: BH144 groundwater elevation.

Source: Gallagher Estates , 2021

The HR Wallingford Report 2 shows groundwater elevations between 2017 and 2021 from continuous monitoring provided by Gallagher Estates. Whilst this appears to document an overall increase through the time period, the groundwater levels are still lower than the observed 6.91-7.55mAOD range recorded pre-dewatering (April-July 2014).

HR Wallingford justified the fluctuation of the groundwater levels around 1m as seasonal variation, inspecting data that was released by Homes England under Freedom of Information RFI3368 Annex C when converted to mAOD doesn't appear to demonstrate the same level of variation as what Wardell Armstrong presented HR Wallingford. Figure 2 shows the Wardell Armstrong recordings of BH144 and Figure 3 is a graph of the data from 16 of Homes England's borehole network between 2018 and 2019. In a number of boreholes the variation is as little as 0.5m.

A possible alternative explanation of the peaks and troughs in Figure 2 is that water could be draining at an almost constant rate through an ingress point into the phase 1 drainage

system, it is notable that the troughs of 2018 and 2019 almost make it to 6mAOD with the drainage features around the eastern edge of H9 being as low as 5.3mAOD.
